CONNECTICUT RIVER BASIN
WOODSTOCK, VERMONT

COX DISTRICT RESERVOIR DAM
VT 00234

PHASE I INSPECTION REPORT
NATIONAL DAM INSPECTION PROGRAM

OCTOBER 1979

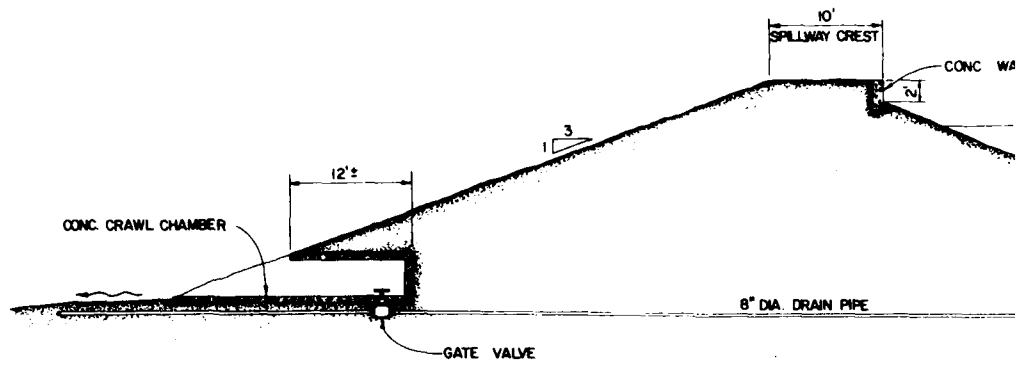
SECTION C-C

The pond is drained by an 8" Dia. pipe as shown in Section C-C, Figure 2/2. The pipe is controlled by valve located in concrete chamber. It was reported that pond drain is in good condition.
